## SQUAT® Exceeds All Expectations During Validation Program at Purolator Canada

### PROJECT SUMMARY REPORT

This report describes the In-Service Validation program conducted by Purolator Canada to evaluate the performance and reliability of the 4 Point SQUAT® Kneeling Suspension installed on an E-450 Parcel Delivery Van.

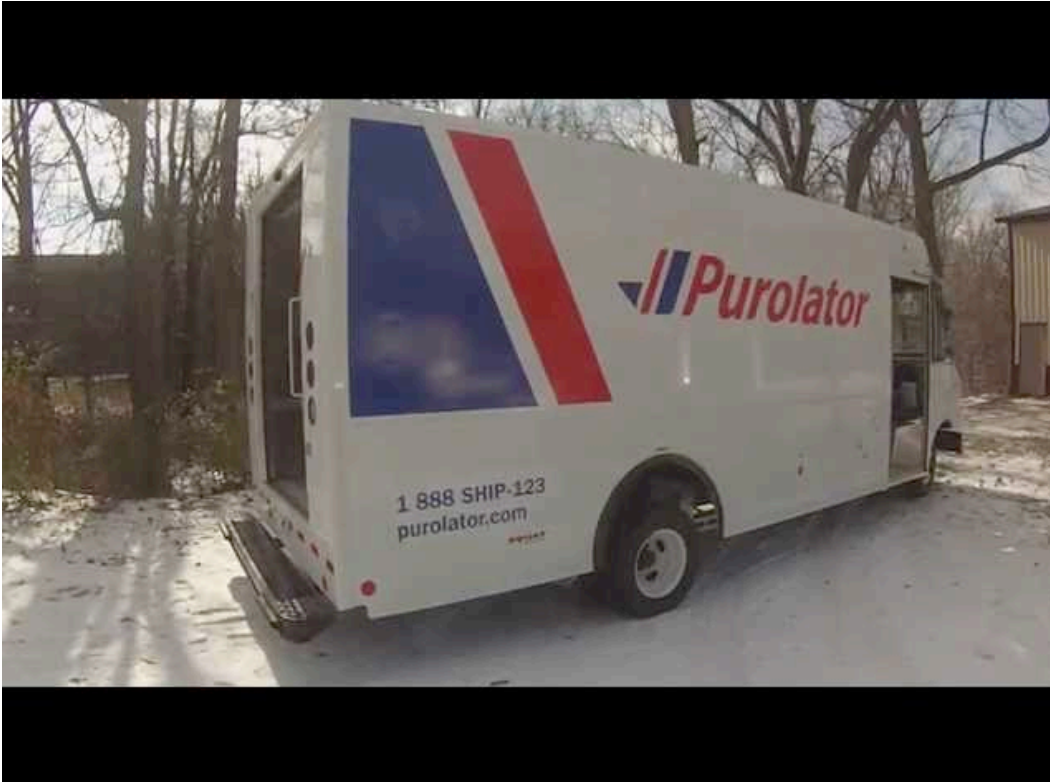
**DSC SQUAT® Equipped Ford E450 Purolator Parcel Van Demonstrator: 4-Point System**

### **Fast-Acting Fully Automatic Hydraulic OEM Leaf Spring (rear) and Coil Spring (front) Kneeling Suspension**

- Maintains the OEM leaf spring. No Air Bags, Compressors, Leveling Valves, etc.
- Enables Rear Loading Decks To Be Automatically Lowered up to 12”
- Enables Front Vehicle Accessibility To Be Automatically Lowered up to 5”
- Provides The Best In Vehicle Accessibility, Resulting In Improved Overall Safety
- Fast - Lowers/Raises < 5 Seconds
- Quiet - No compressors, dryers, etc.
- Excellent Stability & Handling
- Simple Operation & Simple Installation
